NASA/TP-97-206257

The Characteristics of Fatigue Damage in the Fuselage Riveted Lap Splice Joint

Robert S. Piascik
Langley Research Center, Hampton, Virginia

November 1997

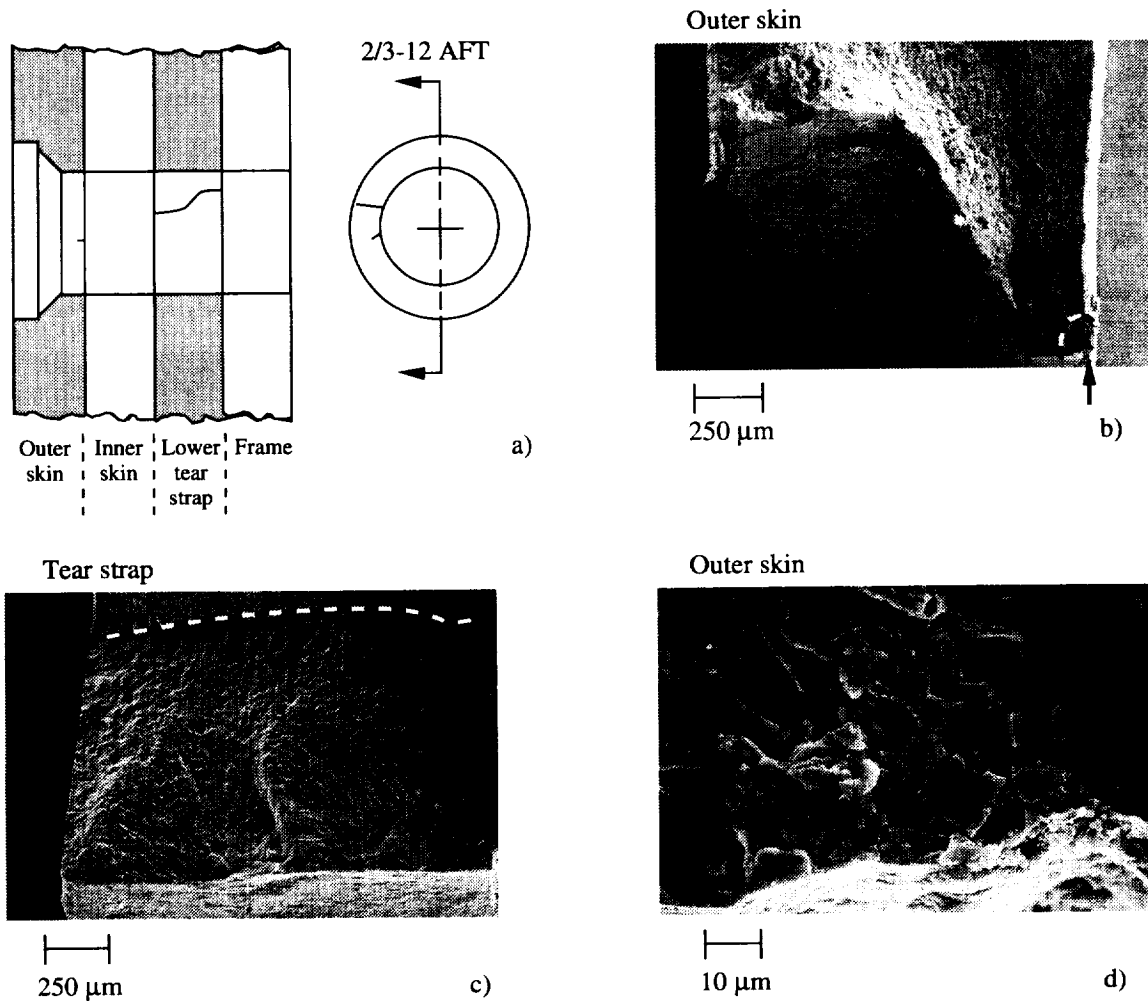
Figure 8.25 a) The schematic shows the rivet hole 2/3-12 configuration and the location of one outer skin fatigue crack and one lower T.S. fatigue crack oriented in the aft direction and at about the 9 and 10 o'clock positions, respectively. b) The SEM micrograph shows the fatigue crack fracture surface (arrow) located at the shank region of the rivet hole contained in the outer skin. The dashed line marks the fatigue crack front. c) The SEM micrograph shows the through-thickness fatigue crack that has propagated from the rivet hole (bottom on Figure 8.35.c) in the lower T.S. The dashed line marks the fatigue crack front. d) The SEM micrograph shows the crack initiation region marked by arrow in Figure 8.25.b.

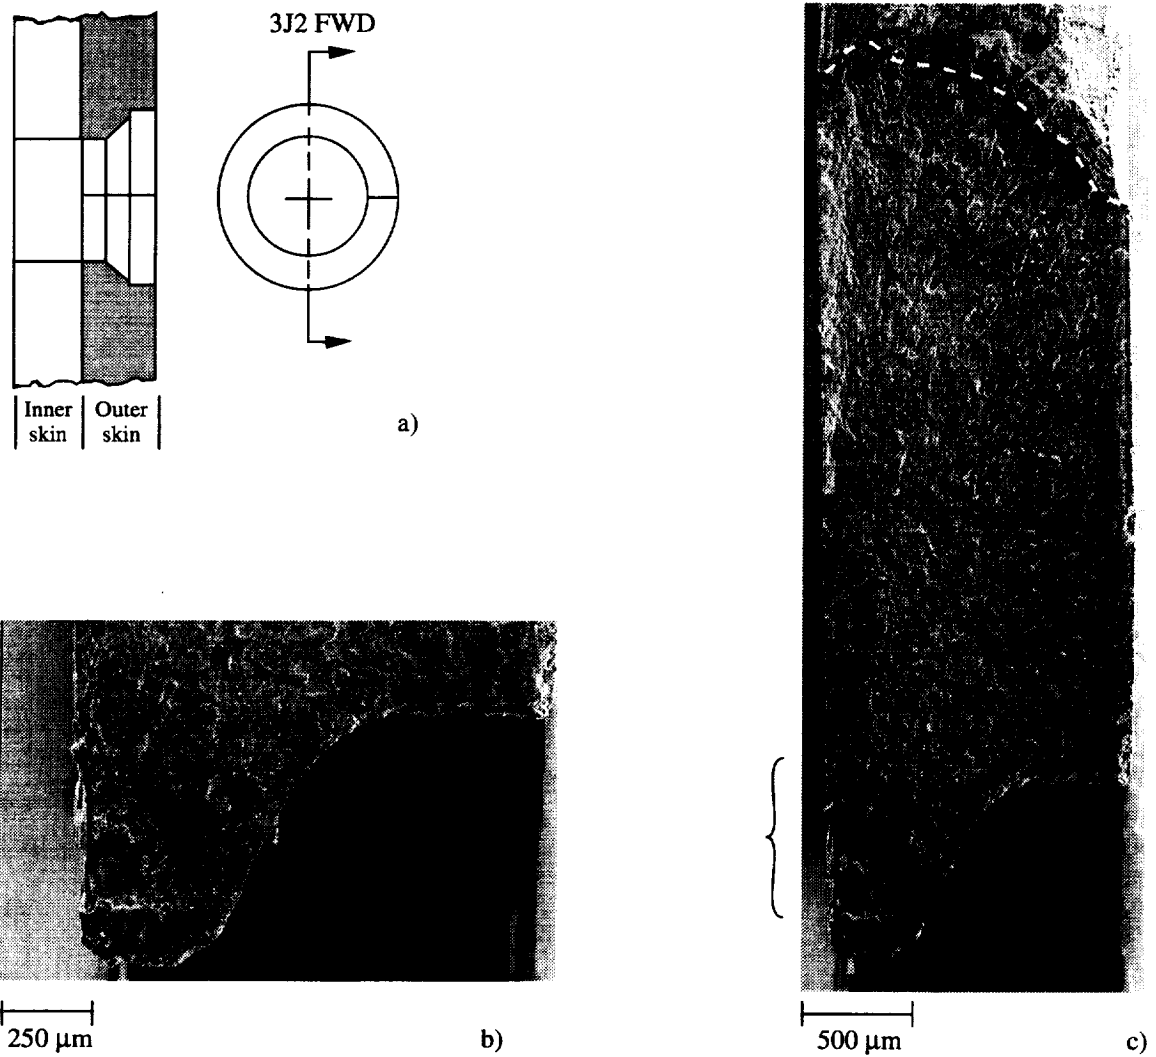
Figure 9.11 a) The schematic shows the rivet hole 3J2 configuration and the location of the outer skin fatigue crack oriented in the forward direction and about the 3 o'clock position. b) The SEM micrograph shows the fatigue fracture surface at the rivet hole (bottom of micrograph). c) The SEM micrograph shows the shank region of the through-thickness fatigue crack and the rivet hole (bottom of the micrograph). The dashed line marks the fatigue crack front and the bracket shows the likely region of initiation.

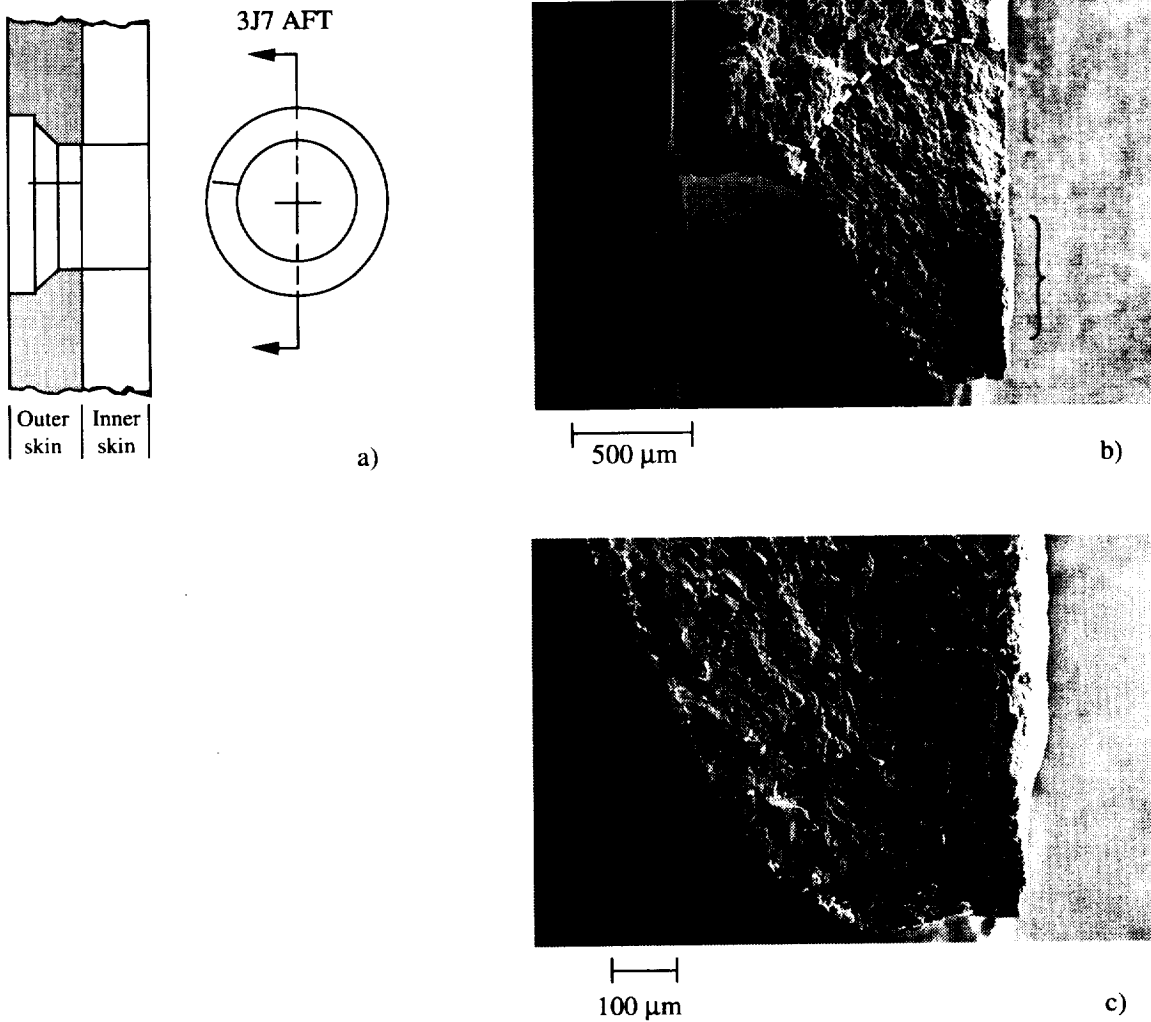
Figure 9.20 a) The schematic shows the rivet hole 3J7 configuration and the location of the outer skin fatigue crack oriented in the aft direction above the 9 o'clock position. b) The SEM micrograph shows the fatigue crack at the rivet hole (bottom). The bracket shows the likely crack initiation region along the faying surface and the dashed line marks the fatigue crack front. c) The SEM micrograph shows the fatigue crack fracture surface at the rivet hole shank region.

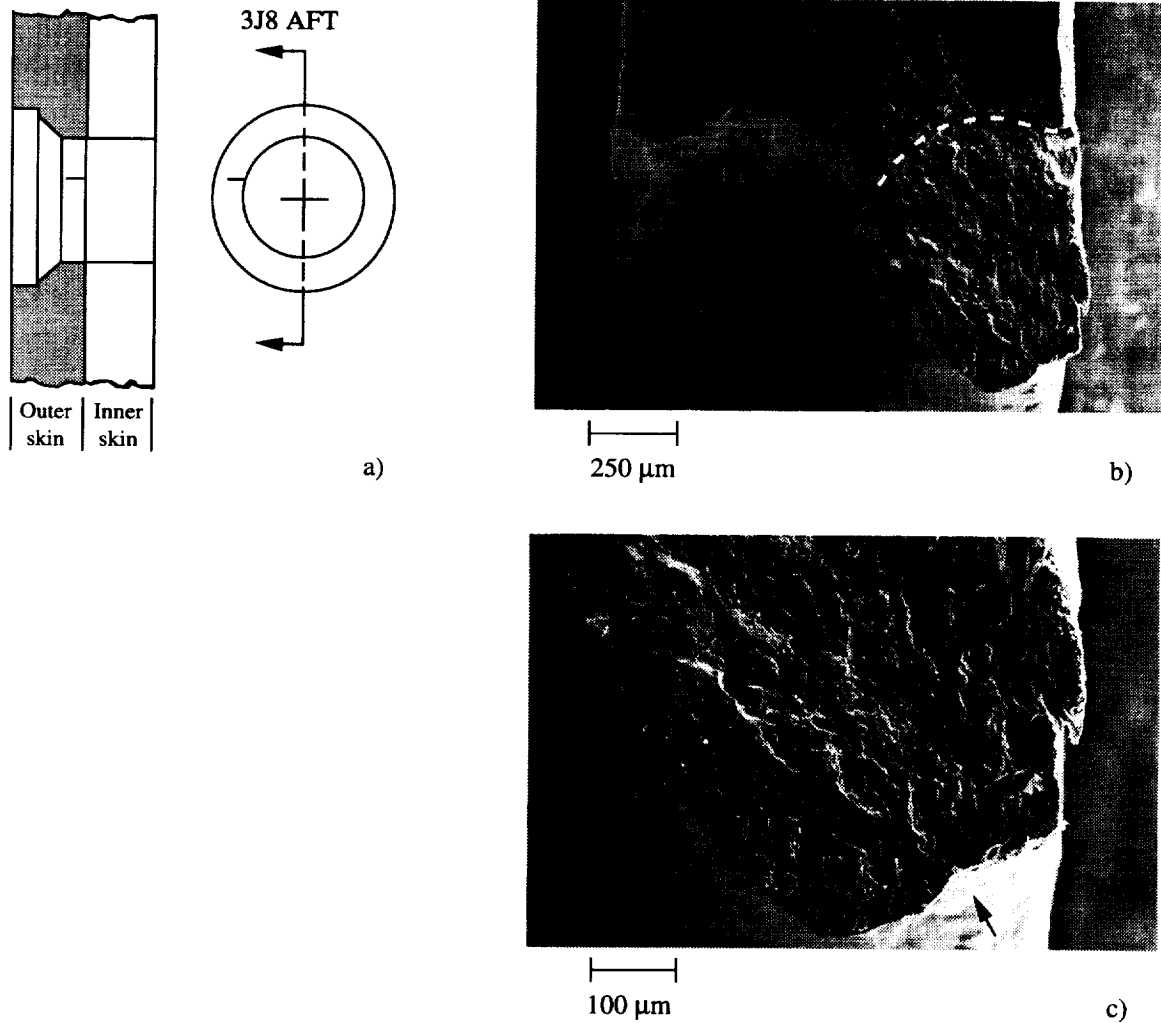
Figure 9.21 a) The schematic shows the rivet hole 3J8 configuration and the location of the outer skin fatigue crack oriented in the aft direction and about the 10 o'clock position. b) The SEM micrograph shows the fatigue crack at the rivet hole (bottom). The dashed line marks the fatigue crack front. c) The SEM micrograph shows the fatigue crack fracture surface at the rivet hole shank region. The arrow marks the likely region of crack initiation.

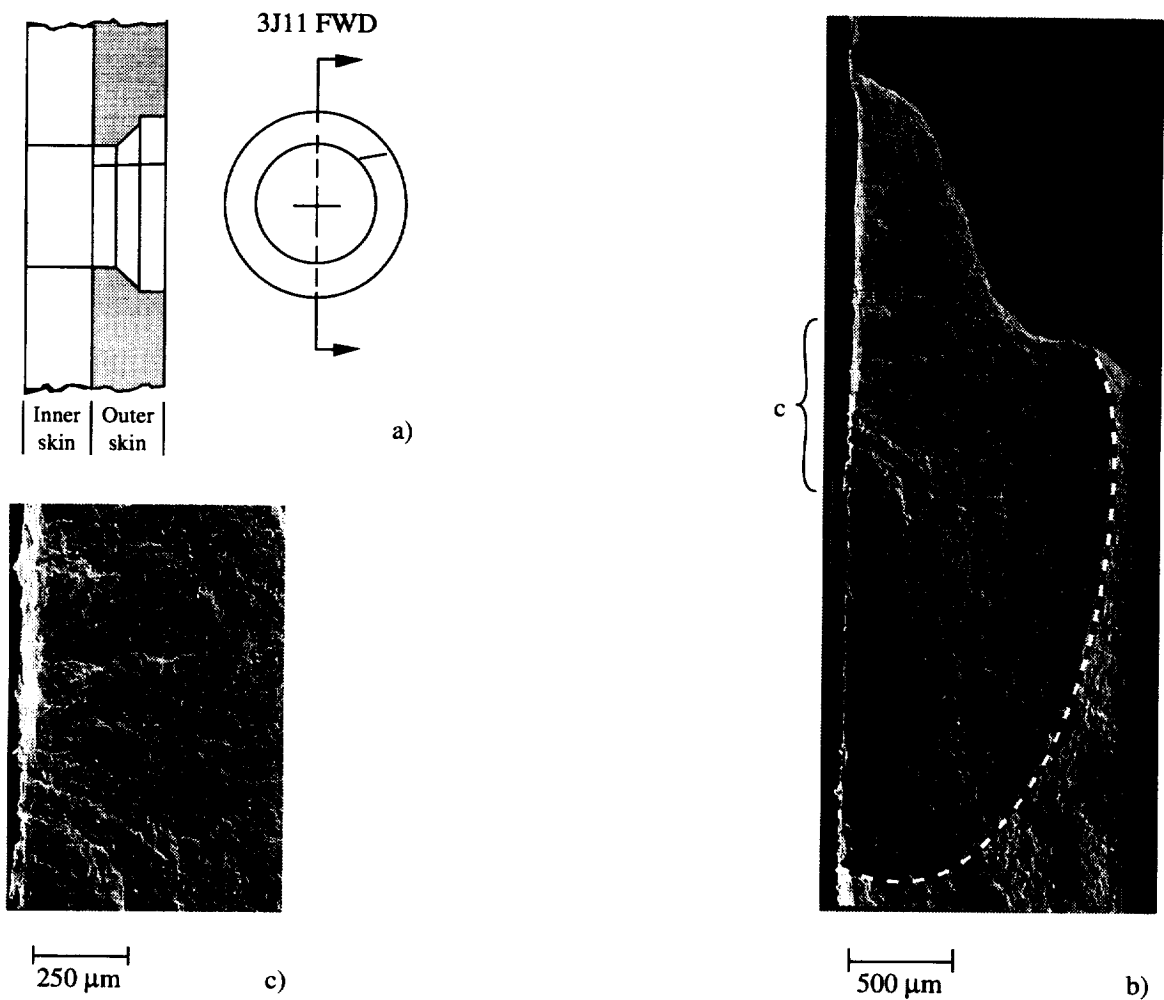
Figure 9.26 a) The schematic shows the rivet hole 3J11 configuration and the location of the outer skin fatigue crack oriented in the forward direction and about the 2 o'clock position. b) The SEM micrograph shows the fatigue crack at the rivet hole (top). The bracket locates the region of crack initiation along the faying surface and the dashed line marks the fatigue crack front. c) The SEM micrograph shows the crack initiation region "c" in Figure 9.26.b.

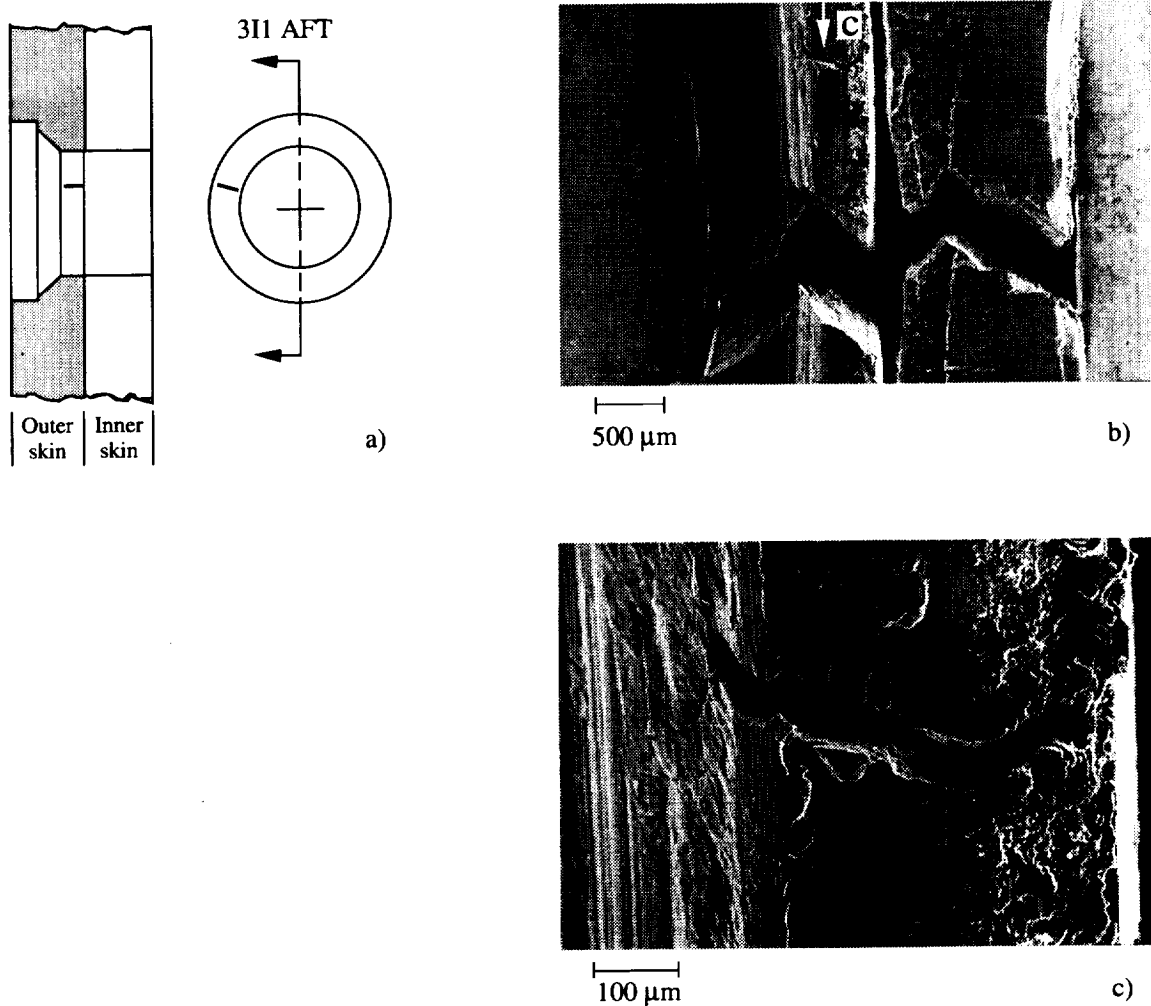
Figure 9.33 a) The schematic shows the rivet hole 3I1 configuration and the location of the outer skin fatigue crack oriented in the aft direction and about the 10 o'clock position. b) The SEM micrograph shows the partially strained to failure specimen oriented as shown in Figure 9.33.a.; shown is the outer skin on the left and the inner skin to the right. The partially opened outer skin fatigue crack is identified by the arrow. c) The SEM micrograph shows region "c" in Figure 9.33.b at high magnification. The fatigue crack was partially opened during the destructive examination. SEM examination into the opened crack confirmed transgranular fatigue crack growth.

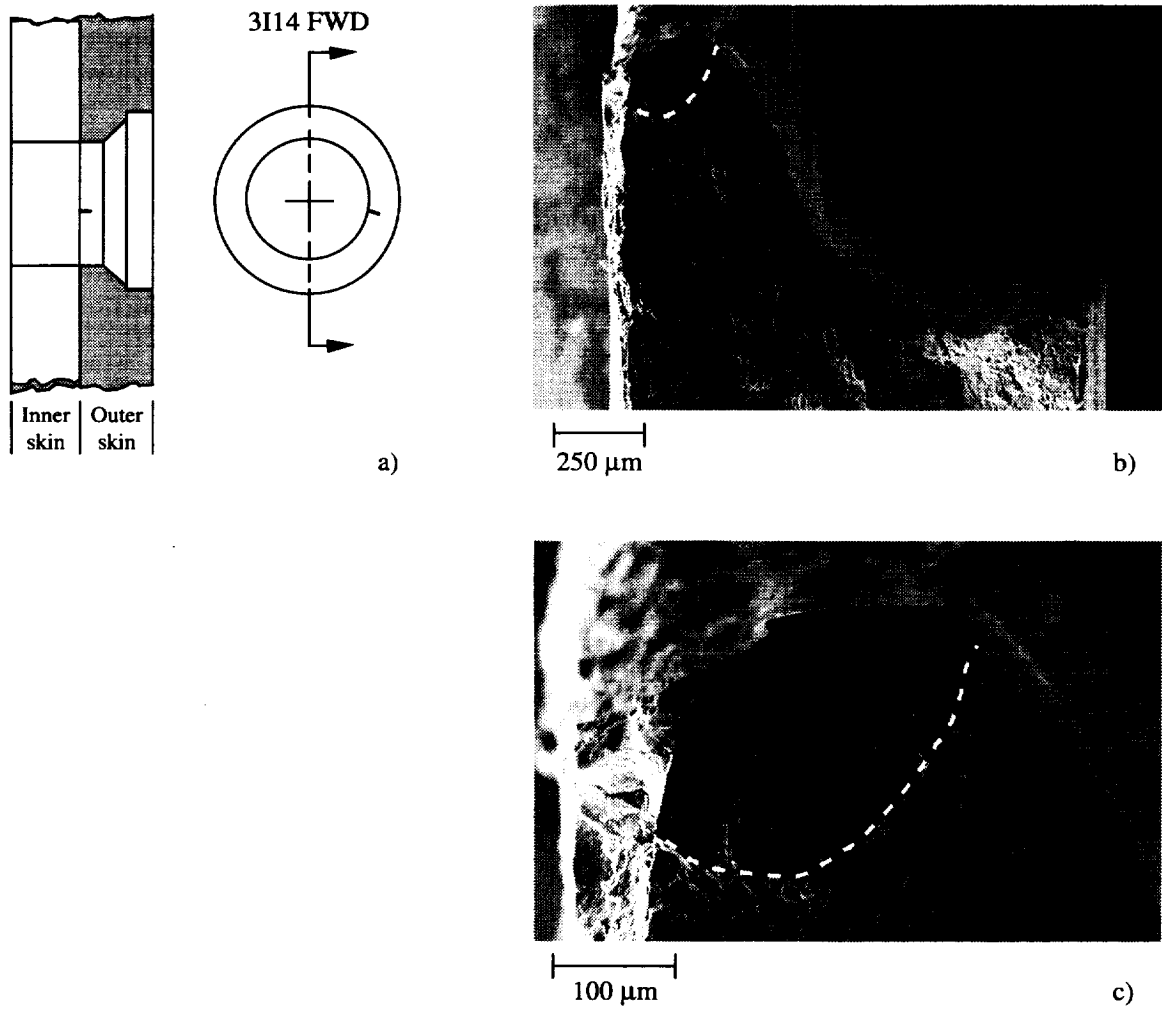
Figure 9.36 a) The schematic shows the rivet hole 3I14 configuration and the location of the outer skin fatigue crack oriented in the forward direction below the 3 o'clock position. b) The SEM micrograph the fatigue crack and the rivet hole. The dashed line marks the fatigue crack front. c) The SEM micrograph shows the region of crack initiation at the rivet hole shank.

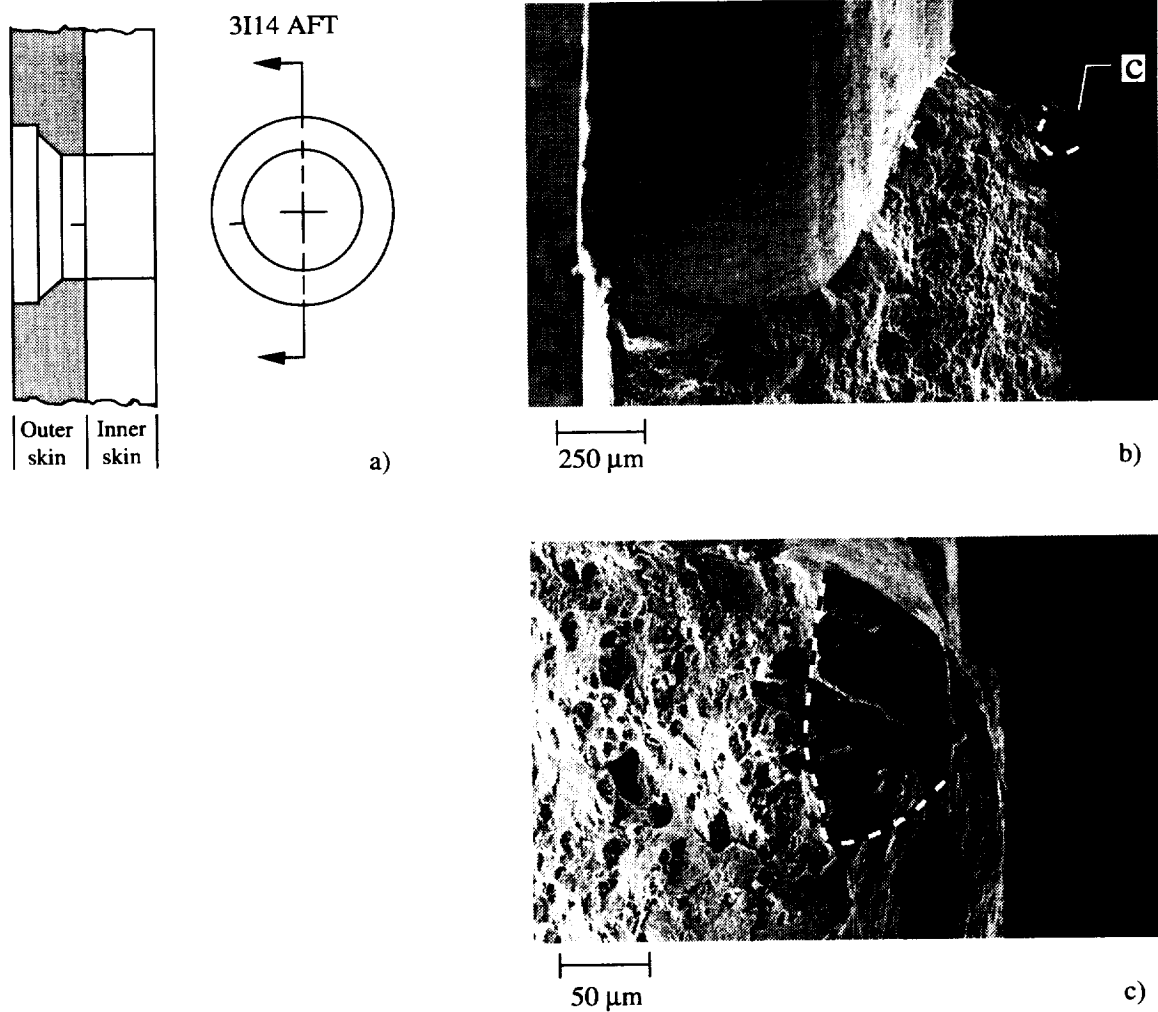
Figure 9.37 a) The schematic shows the rivet hole 3I14 configuration and the location of the outer skin fatigue crack oriented in the aft direction below the 9 o'clock position. b) The SEM micrograph shows the fatigue crack at the inboard corner of the rivet hole. The dashed line marks the fatigue crack front. c) The SEM micrograph shows the region of crack initiation at the rivet hole shank region "c" in Figure 9.37.b. The dashed line marks the fatigue crack front.

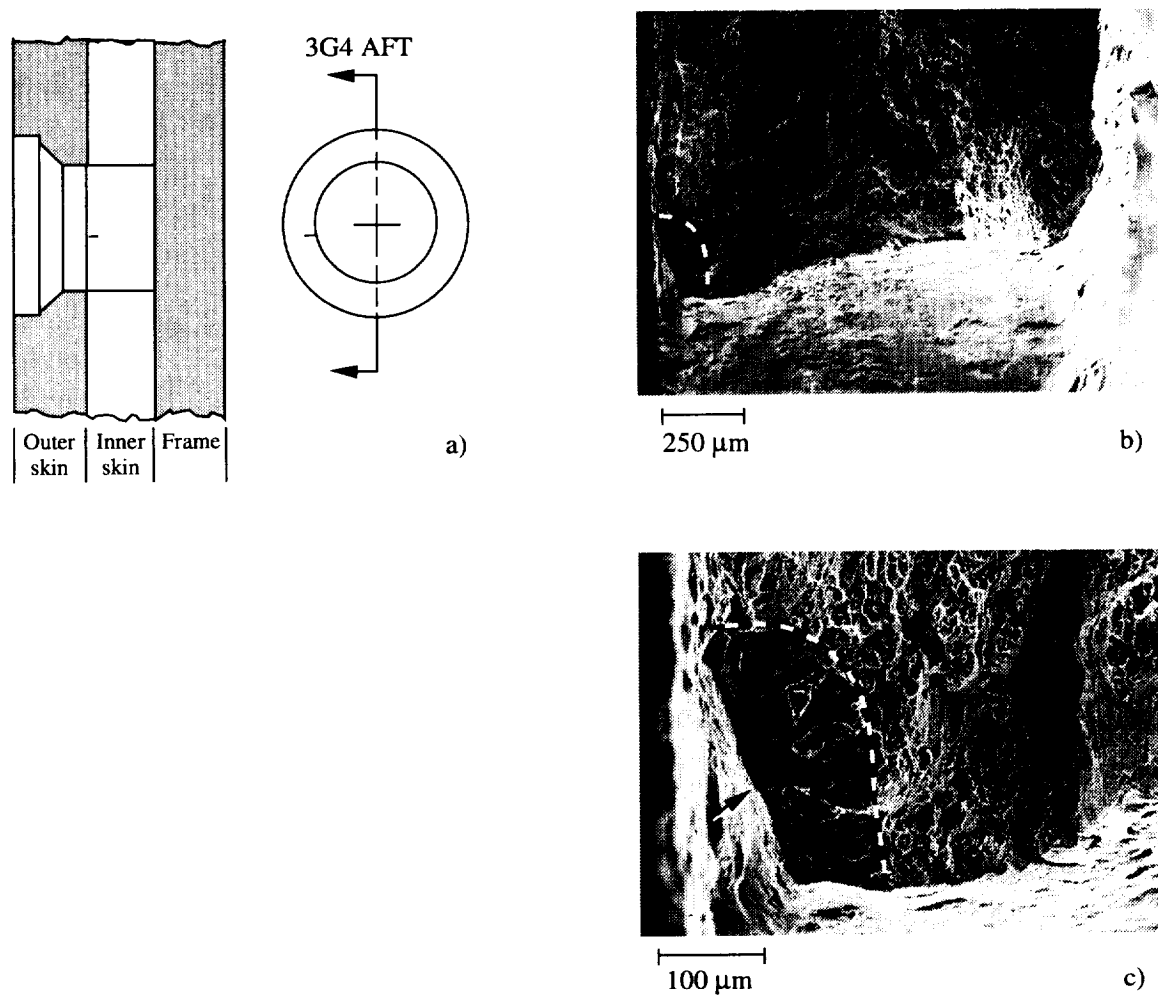
Figure 9.45 a) The schematic shows the rivet hole 3G4 configuration and the location of the inner skin fatigue crack oriented in the aft direction below the 9 o'clock position. b) The SEM micrograph shows the fatigue crack at the outboard corner of the rivet hole. The dashed line marks the fatigue crack front. c) The SEM micrograph shows the region of crack initiation (arrow) at the outboard corner of the rivet hole. The dashed line marks the fatigue crack front.

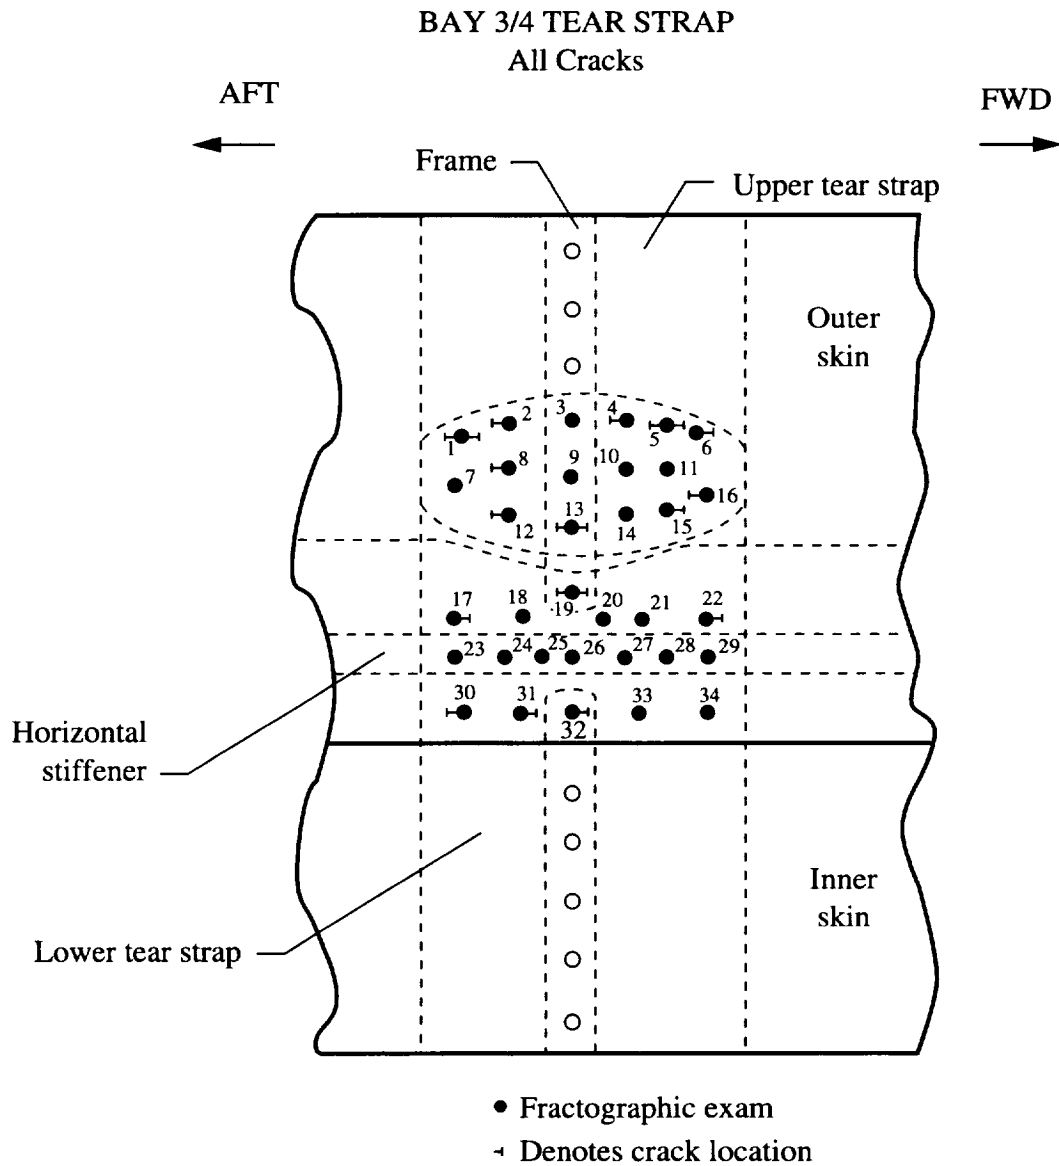
Figure 10.1 The schematic shows the location of all fatigue cracks found in the bay 3/4 tear strap by destructive examination. All filled and numbered rivet holes were destructively examined.

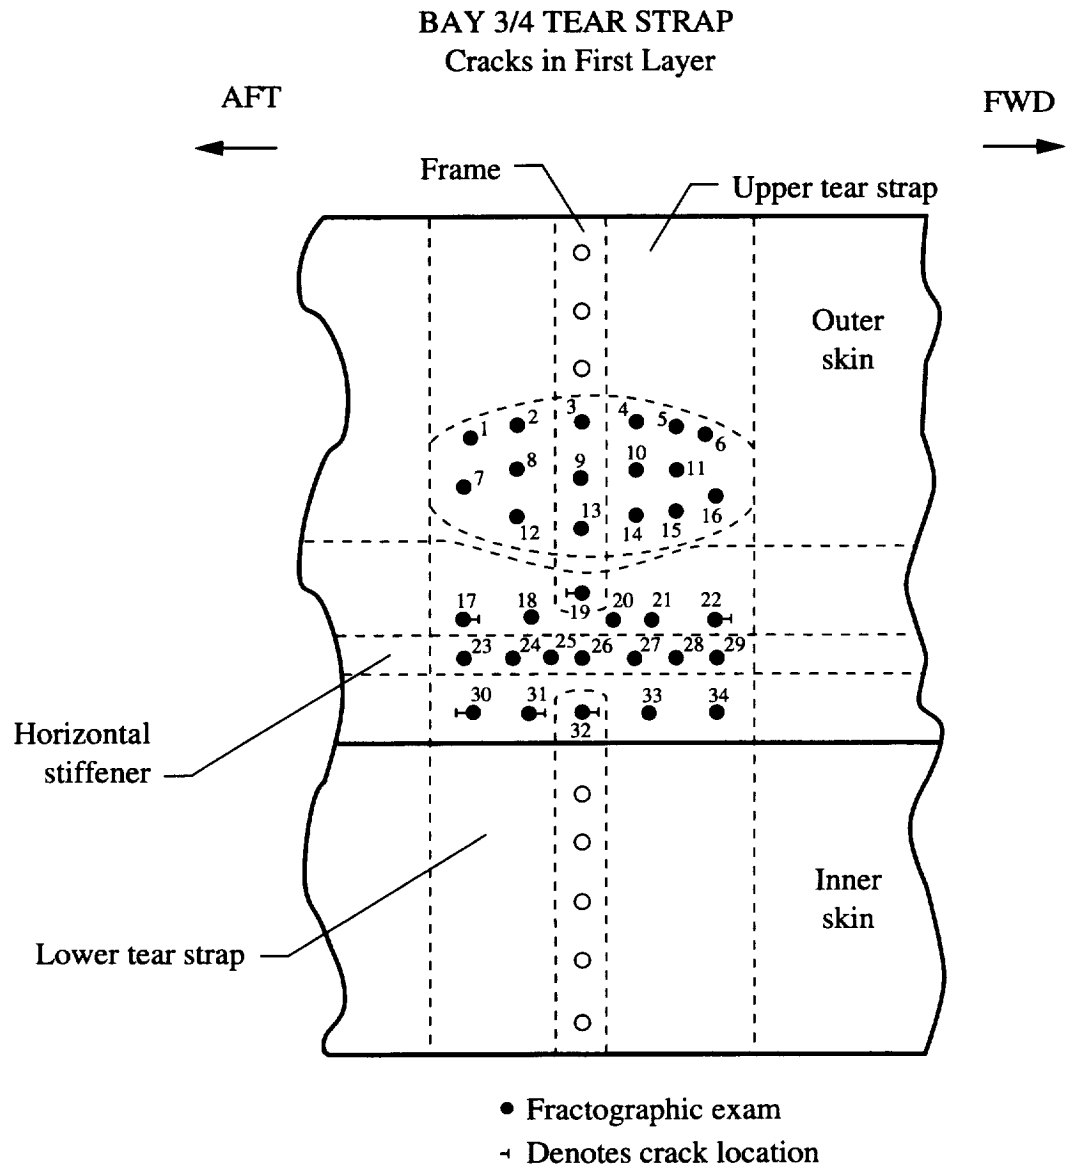
Figure 10.2 The schematic shows the location of fatigue cracks found in the first layer (outer skin) of the bay 3/4 tear strap by destructive examination.

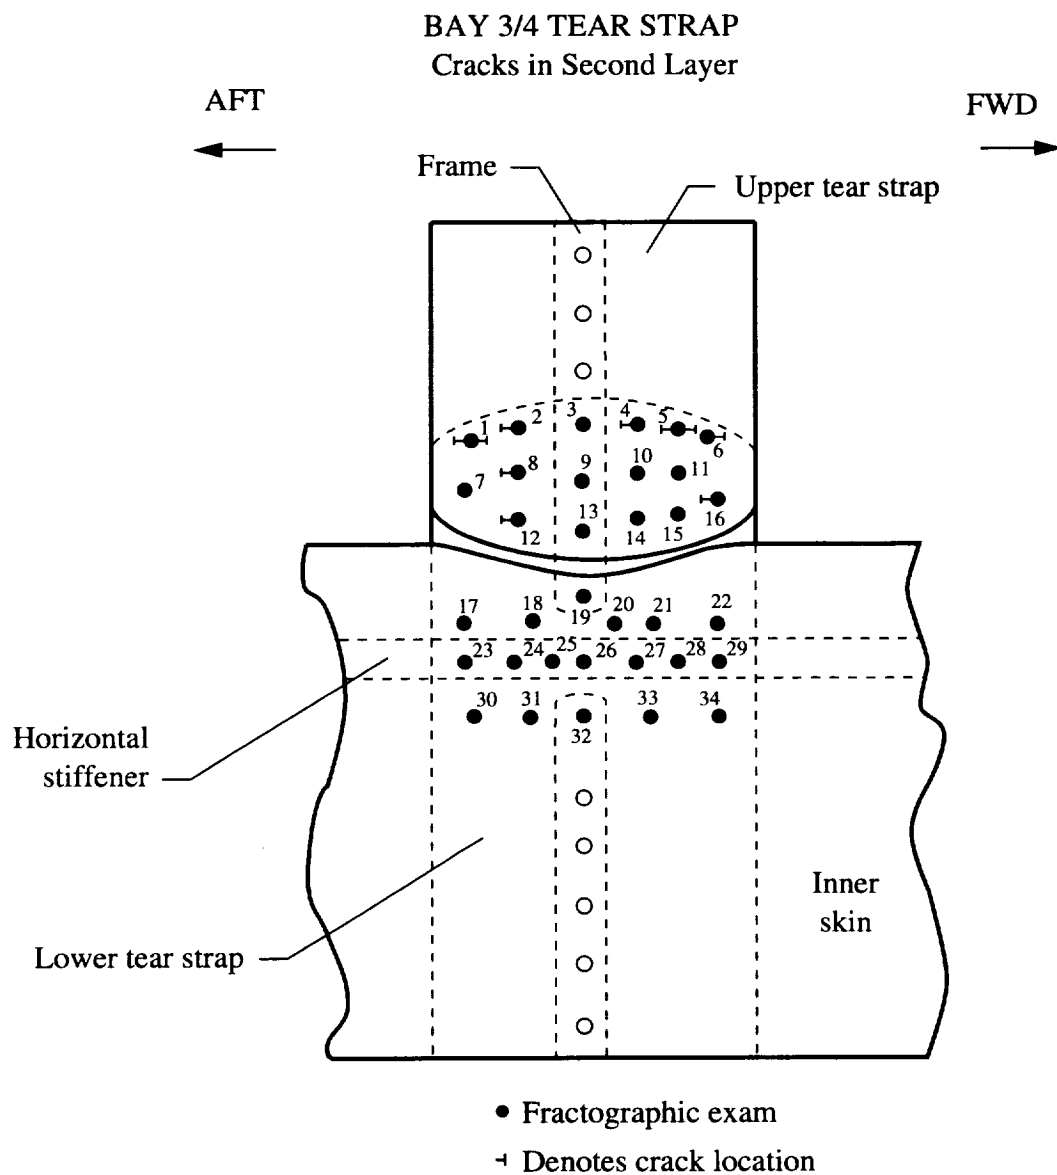
Figure 10.3 The schematic shows the location of fatigue cracks found in the second layer (inner skin and upper tear strap) of the bay 3/4 tear strap by destructive examination.

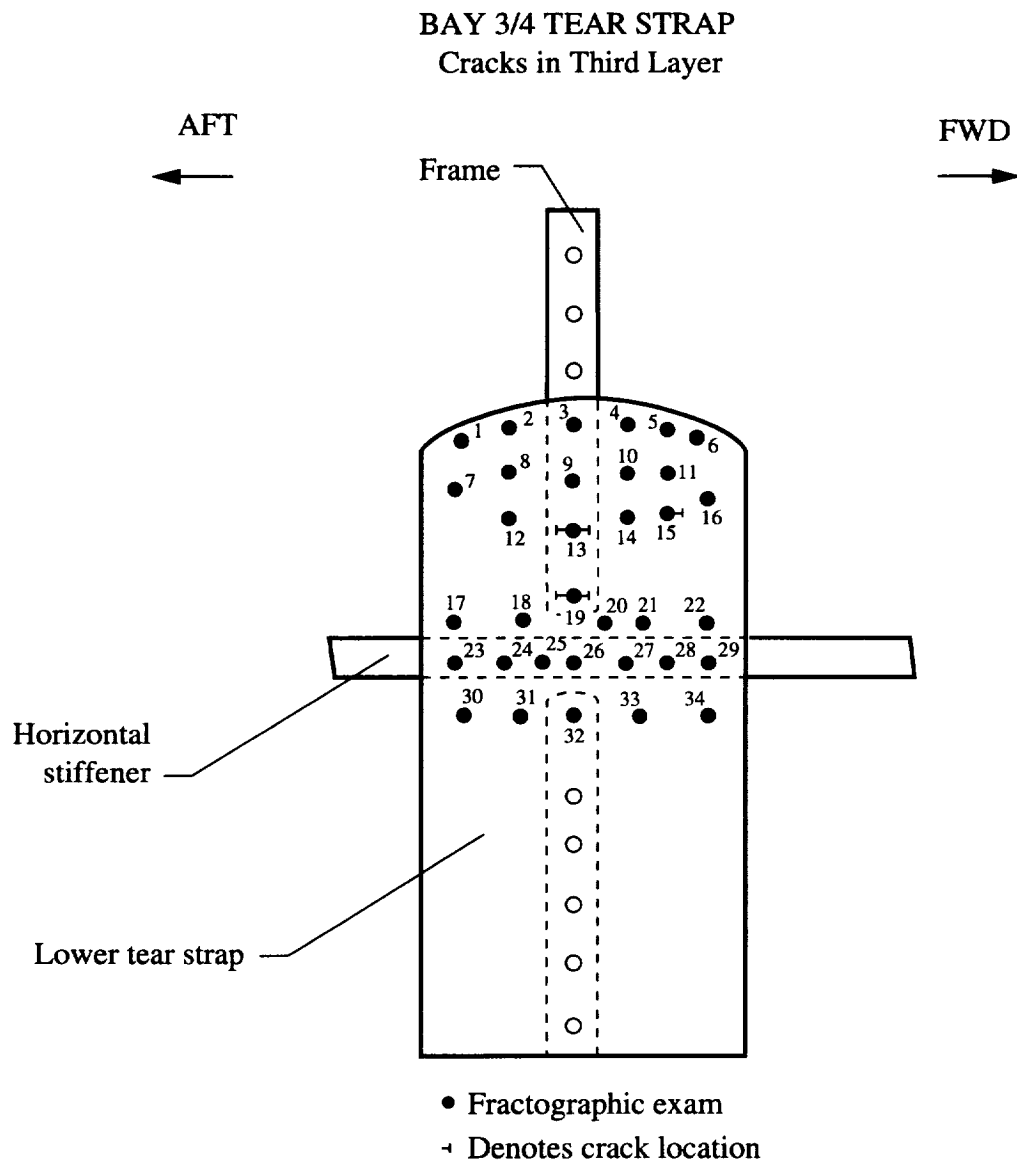
Figure 10.4 The schematic shows the location of one fatigue crack found in the third layer (lower tear strap) of the bay 3/4 tear strap by destructive examination.

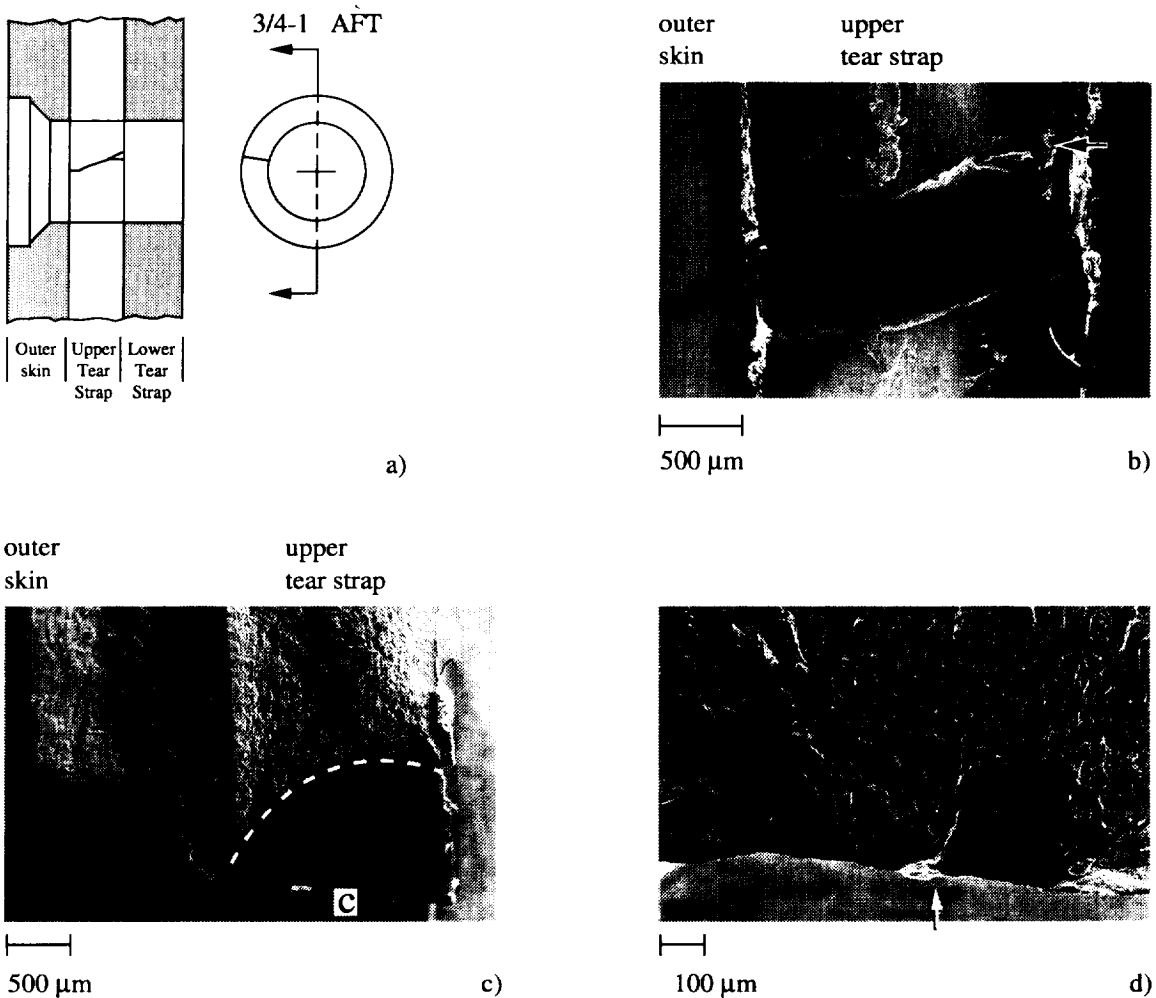
Figure 10.11 a) The schematic shows the rivet hole 3/4-1 configuration and the location of an upper T.S. fatigue crack oriented in the aft direction above the 9 o'clock position. b) The SEM micrograph shows the partially opened upper T.S. crack at the rivet hole surface. To the left is the fractured outer skin. A small partially opened fatigue crack is visible above the main fracture surface (arrow). c) The SEM micrograph shows the location of the fatigue crack contained in the upper T.S. The dashed line marks the fatigue crack front. Here the rivet hole is located at the bottom of the micrograph and the outer skin is located to the left of the fatigue crack region. d) The SEM micrograph shows the region of crack initiation at high magnification, region "c" in Figure 10.10.d. The arrow marks the likely crack initiation site.

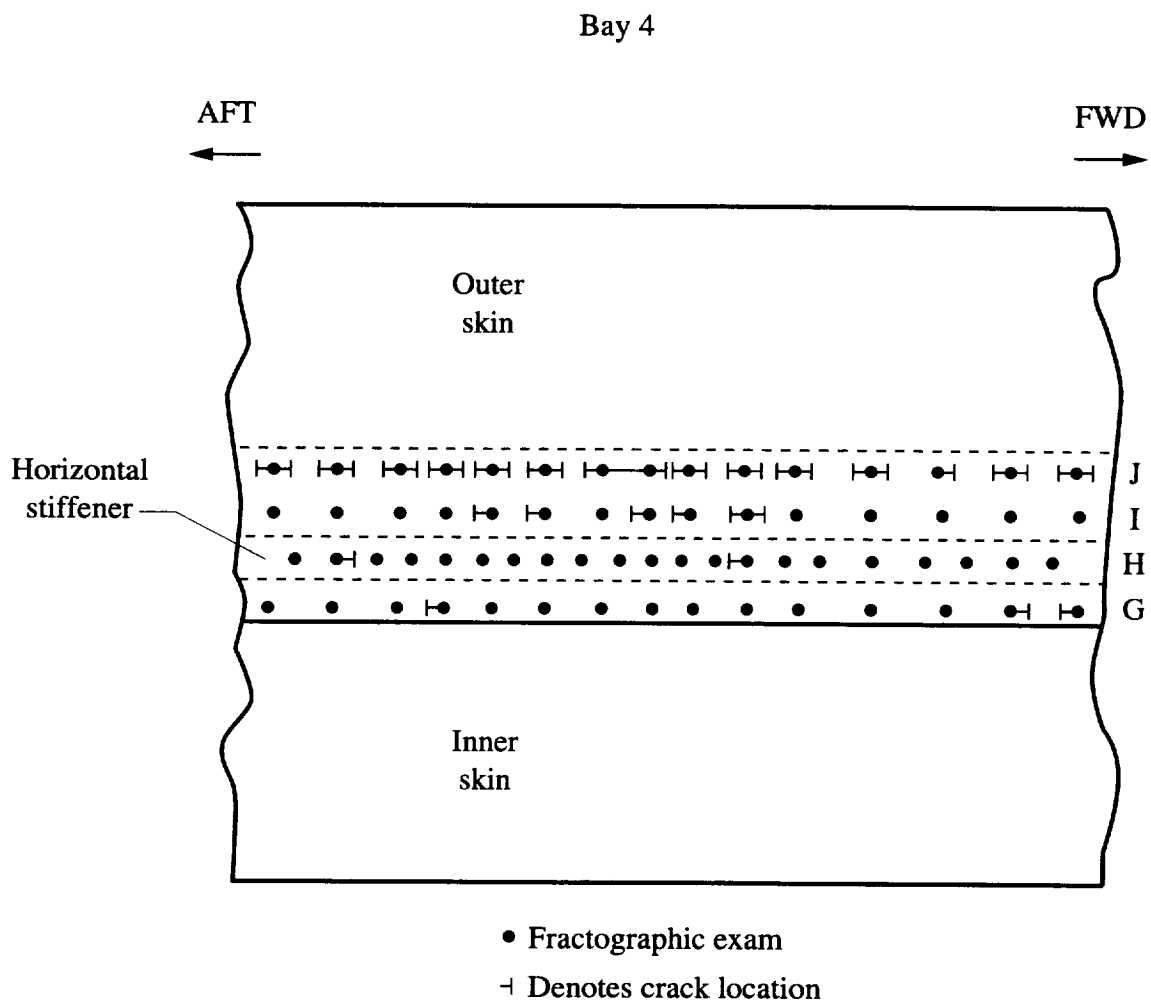
Figure 11.1 The schematic shows the location of all fatigue cracks found in the bay 4 lap splice joint by destructive examination. All bay 4 rivet holes were examined.

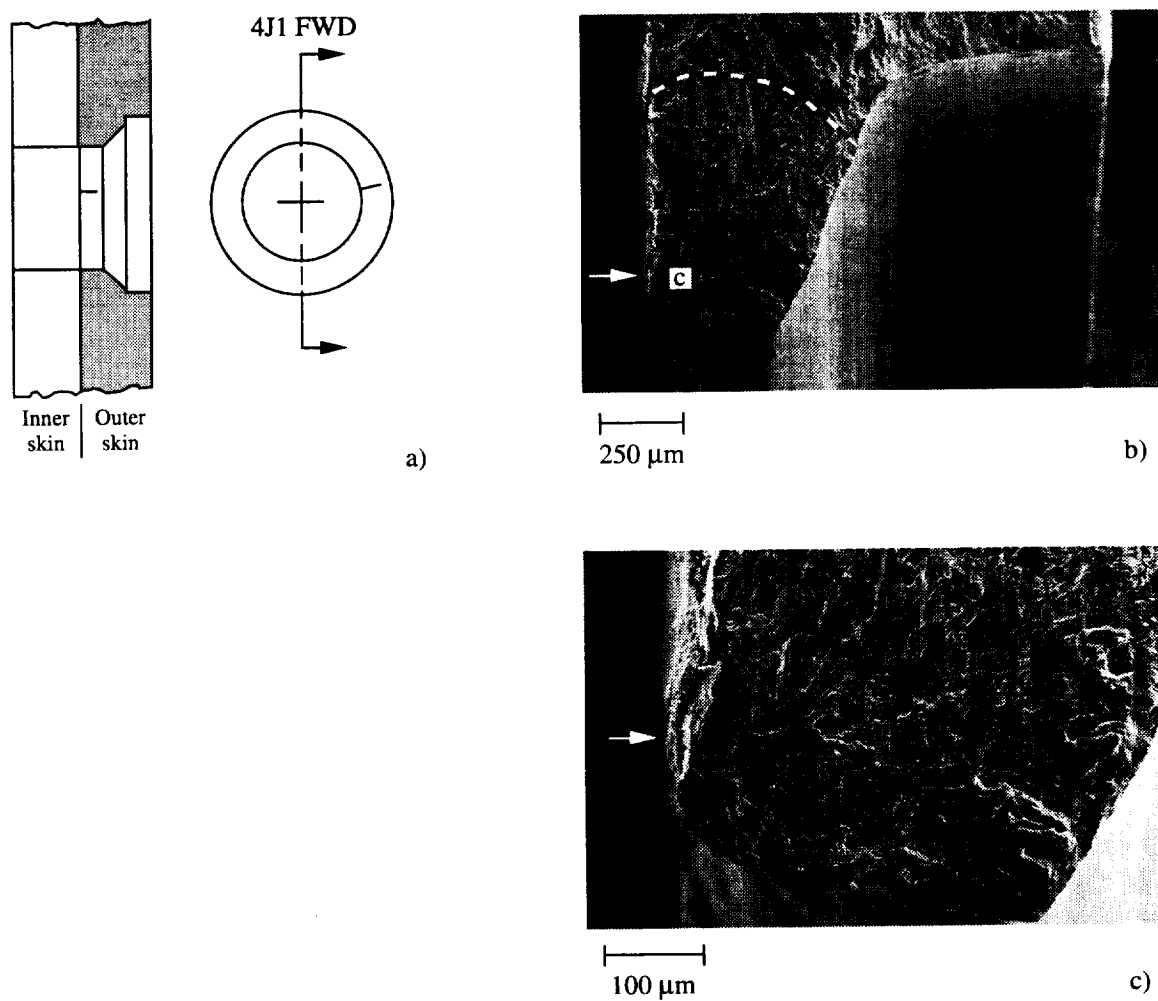
Figure 11.9 a) The schematic shows the rivet hole 4J1 configuration and the location of the outer skin fatigue crack oriented in the forward direction and above the 3 o'clock position. b) The SEM micrograph shows the fatigue crack fracture surface located at the rivet hole shank region. The arrow marks the likely crack initiation region along the faying surface and the dashed line marks the fatigue crack front. c) The SEM micrograph shows the fatigue crack fracture surface at region "c" in Figure 11.9.b. The arrow marks the likely crack initiation region along the faying surface.

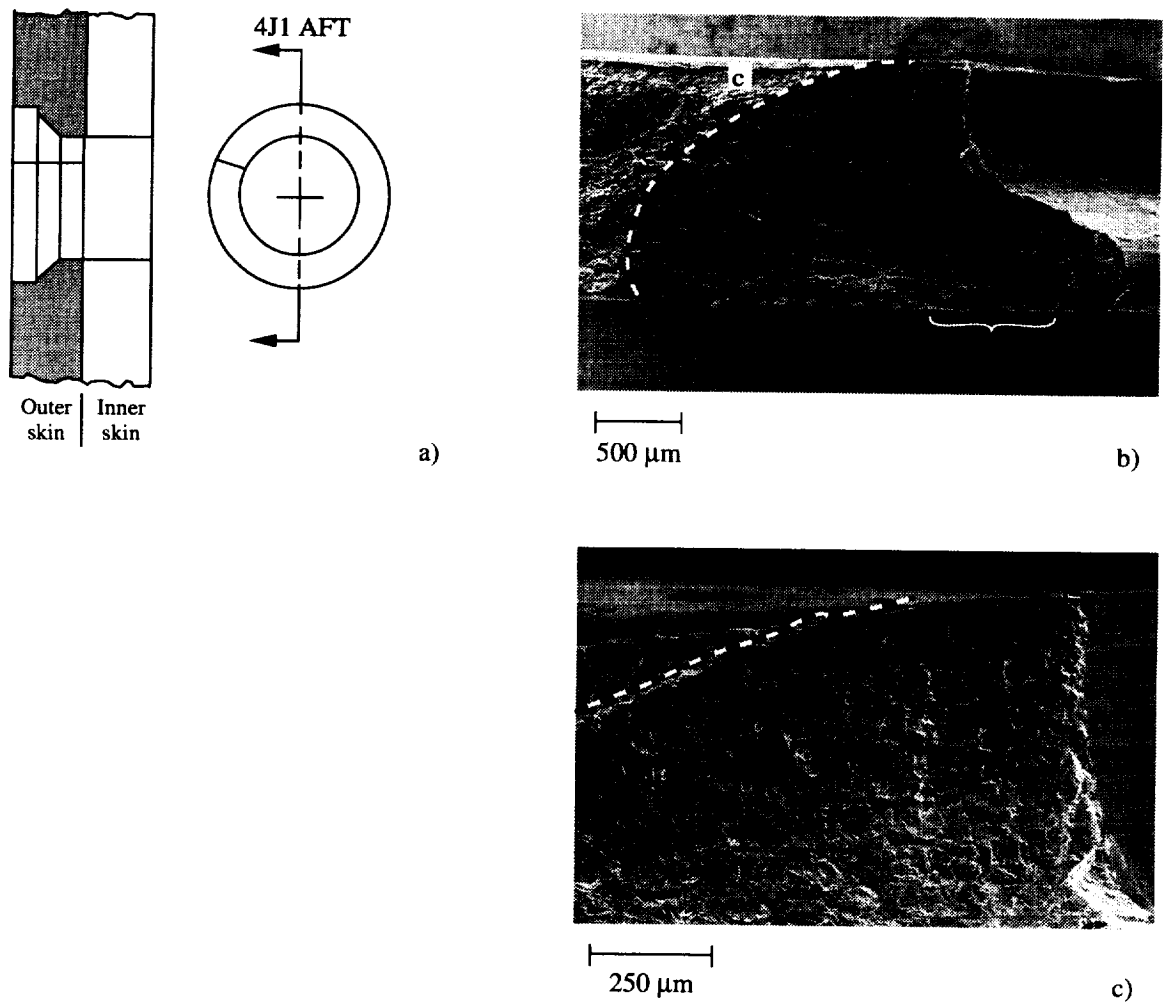
Figure 11.10 a) The schematic shows the rivet hole 4J1 configuration and the location of the outer skin fatigue crack oriented in the aft direction and about the 10 o'clock position. b) The SEM micrograph shows the fatigue crack fracture surface located at the outer skin rivet hole (right). The dashed line marks the fatigue crack front. The bracket marks the region of crack initiation. c) The SEM micrograph shows the fatigue crack front, region "c" in Figure 11.10.b. The dashed line marks the fatigue crack front as it intersects the outboard surface of the outer skin.
